Re: White Mountain Apache Tribe's Unified Watershed Assessment

Enclosed is the FY'98 Unified Watershed Assessment and Watershed Restoration Priority List for the White Mountain Apache Tribe located in Whiteriver, AZ.

This report describes the conditions of watershed health on the White Mountain Apache Reservation. The purpose of this report is to provide information regarding the state of the waters of the Reservation, including the following elements:

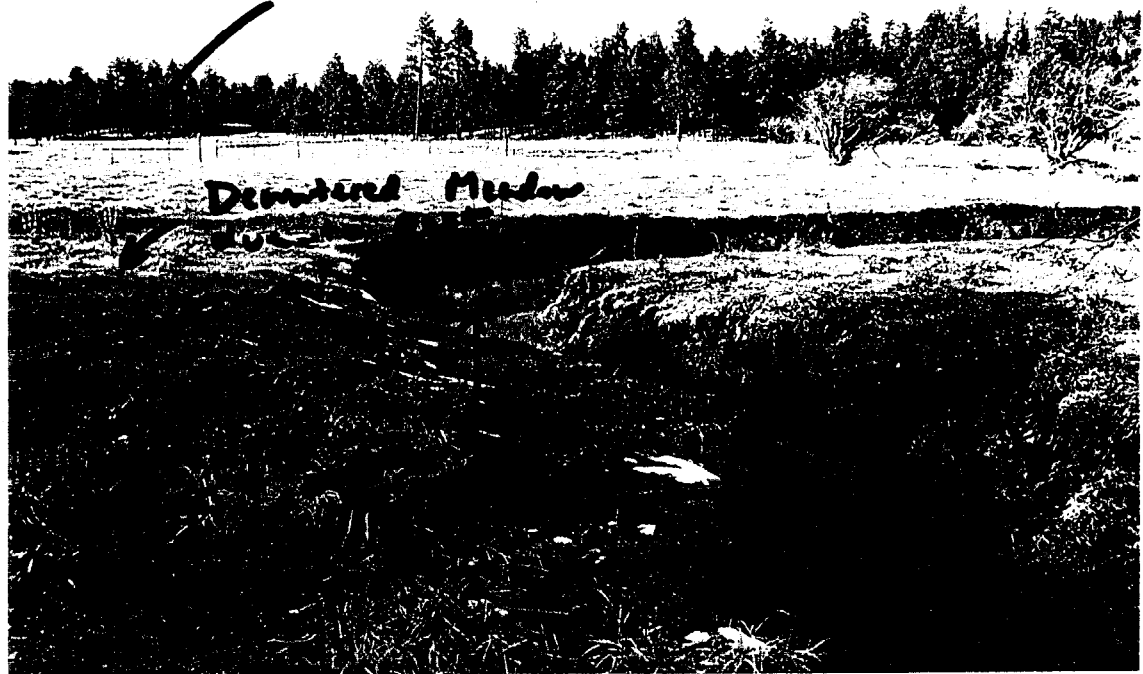
BOTTOM: Gooseberry Creek at the monitoring station in **Haystack Cienega**. The wide, square-bottomed, (Rosgen "F" type) channel does not provide good places for aquatic plants to establish. Riffles would be placed in this mile-long reach to provide such micro-habitats and to spread water over the banks during floods.

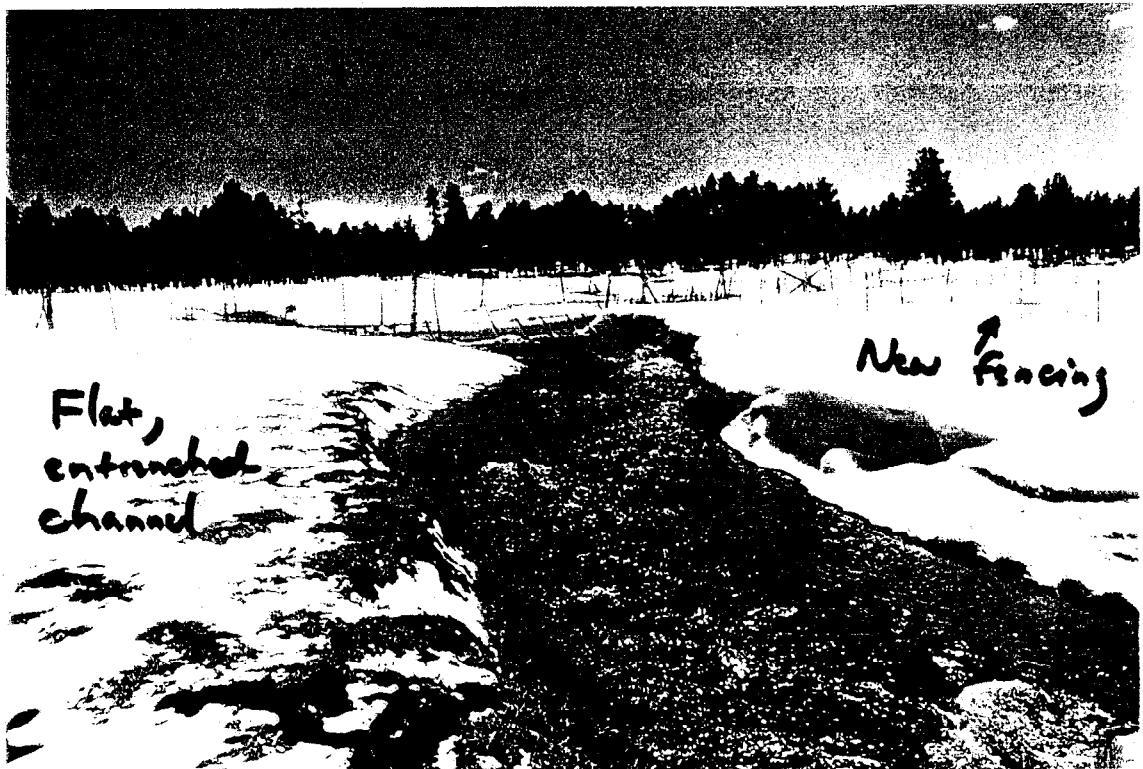
BEFORE: Pacheta Cienega, June 1996. The creek had downcut 1-2 feet due to overgrazing by ungulates. The meadow was fenced in 1996 to reduce grazing pressure. However, rest alone could not cure the disease. Note how low the water surface is in relation to the undercut banks. The downcutting has dried up the meadow so that the sedges are outcompeted by exotic Kentucky Bluegrass.

Before and After Photos Demonstrating the Riffle Bar Restoration Method to be used on the Lofer and Gooseberry Phase II Projects

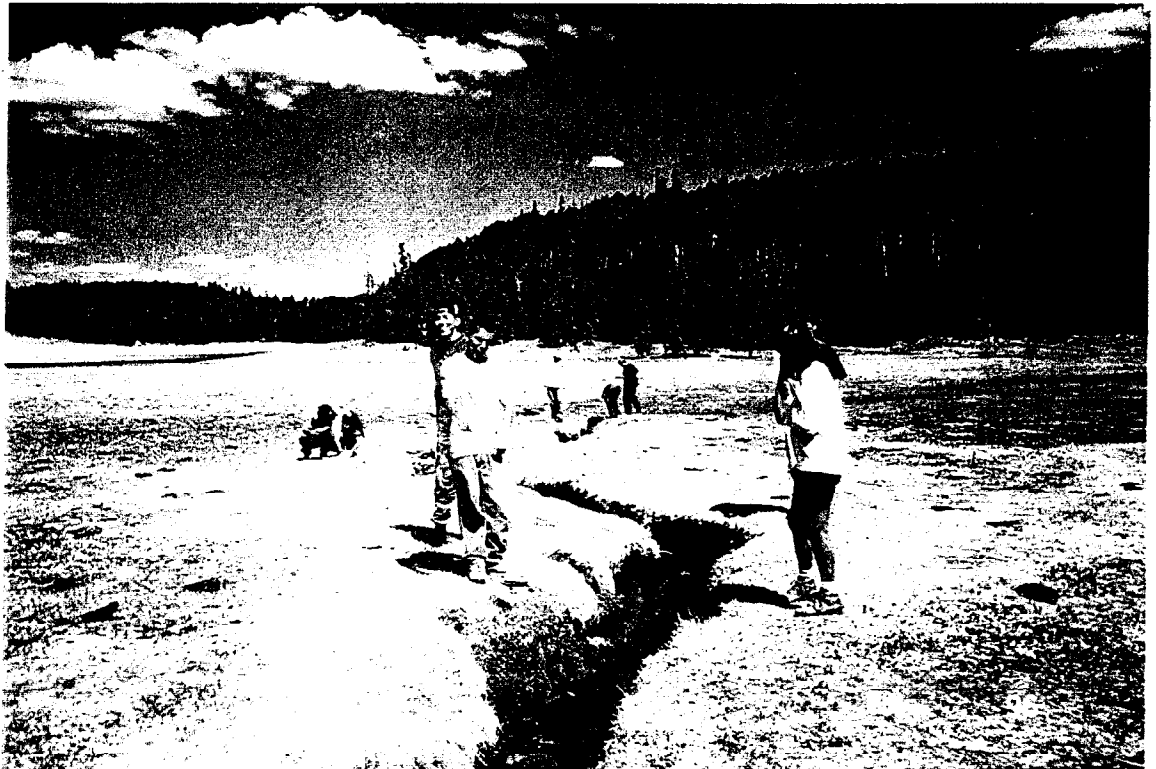
AFTER: Pacheta Cienega, July 1998. Riffle bars were constructed through this reach in 1997. The bars were being raised at the time of the photo (causing the temporary increase in turbidity). Note the height of the water in relation to the stream banks: now the sedges are able to get the water they need. Sedge transplants have successfully established in the constructed riffles. Mark Nemeth, Tribal Fisheries Biologist, and Malchus Baker of the Rocky Mountain Station are examining the dramatic changes.

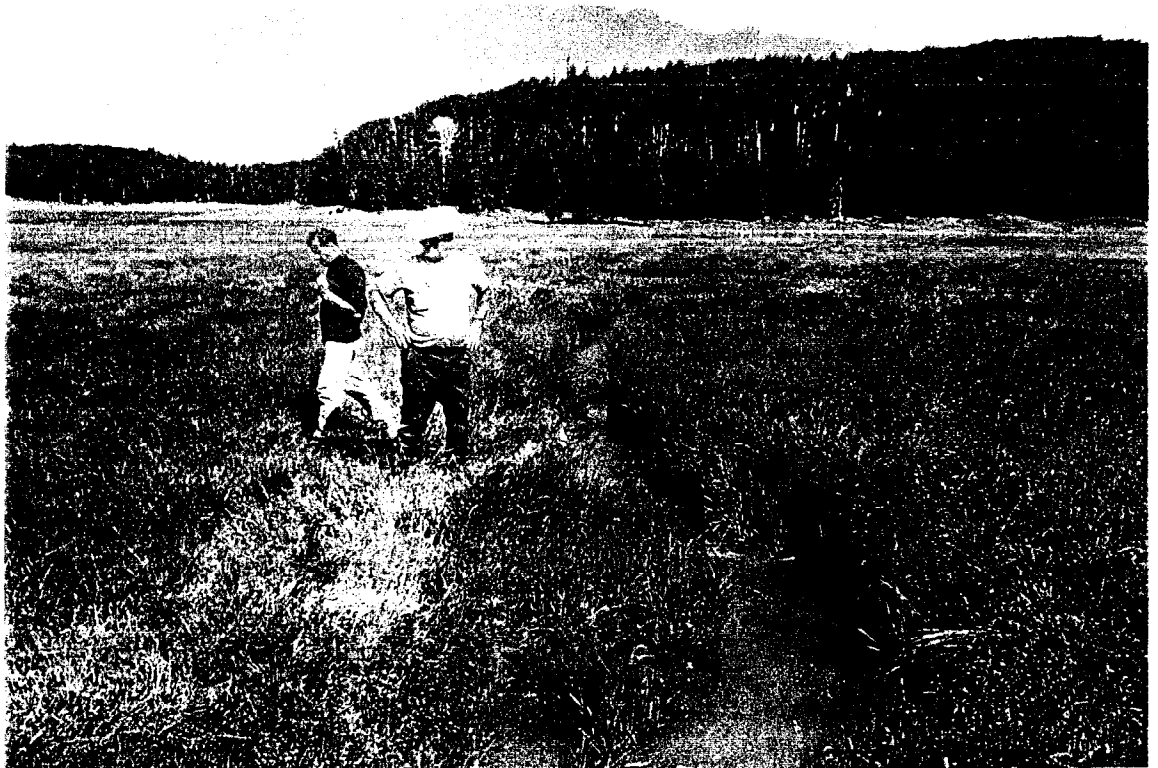
Lofer Cienega Restoration Phase II SITE PHOTOS

Boggy Creek below Station #2 looking north-north west (monitoring cage #3 at right) during spring runoff. Riffles placed in 1997 are dispersing flows across the meadow (riffles are under water where the "white caps" are visible).

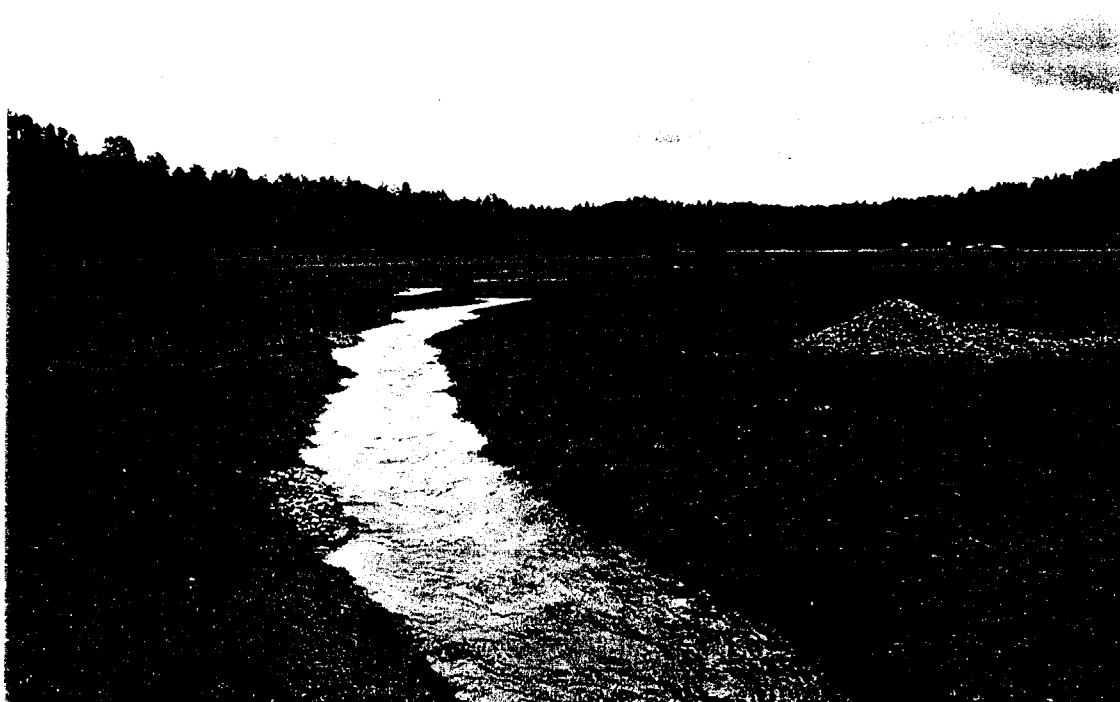
Boggy Creek below Station #3 looking upstream (to the east) showing two riffle bars placed in 1997. Spring runoff has partially eroded the riffle in the foreground due to the undersized material and steep grade. The Phase II Project will use larger materials and more transplants to ensure that the riffles will withstand high flows. Extending the work for three years will allow work to dynamically adjust to changes in the channel.

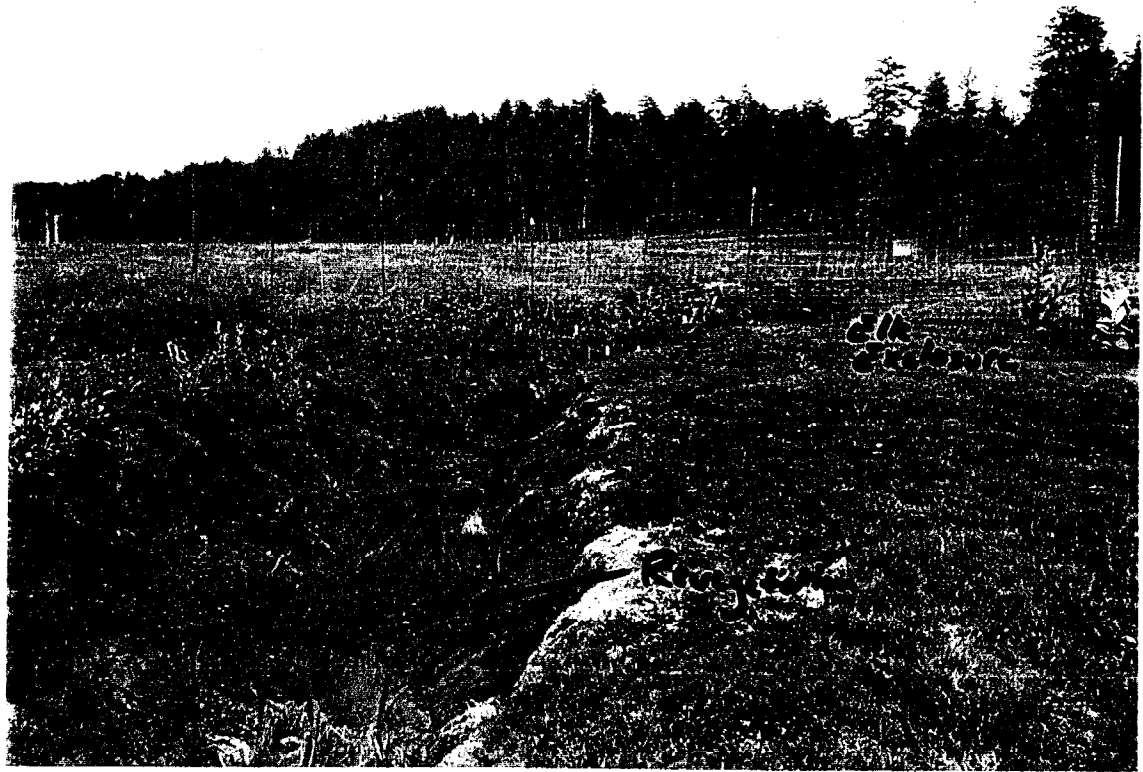
Lofer Station #1
on Lofer Creek
immediately below
elk enclosure, facing
upstream (southeast)

Note revegetation in
channel bottom and
dense growth inside
exclosure; the
headcut appears to
be stable, but
downstream
downcutting still
threatens this reach.

Riffle bars would be
constructed below
this reach.

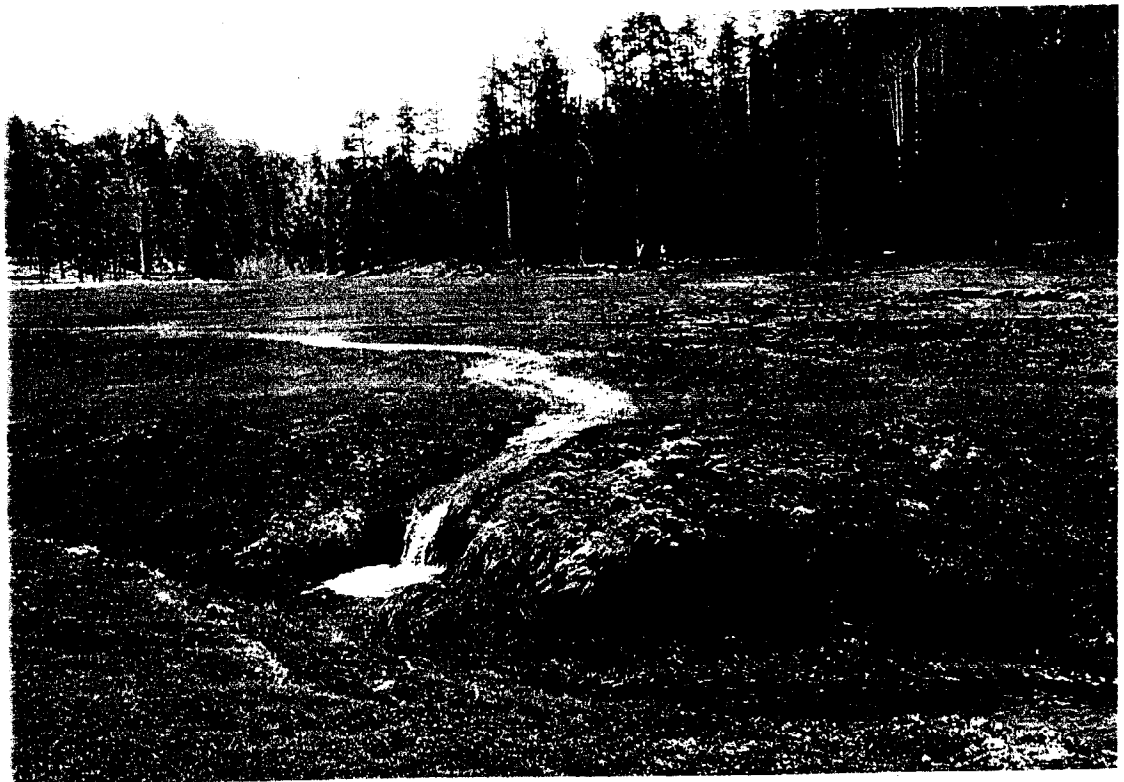
Side gully on Boggy
Creek in the upper
cienega (looking
southeast); although
vegetation is present
and recovering, the
downcut channel is
threatened to erode
further. Riffle bars
would be placed in
this reach to prevent
further downcutting
and allow the
channel to stabilize.
This photo shows how
the meadow is
dewatered due to
the downcutting, since
water runs off
violently rather
than soaking into
the ground.

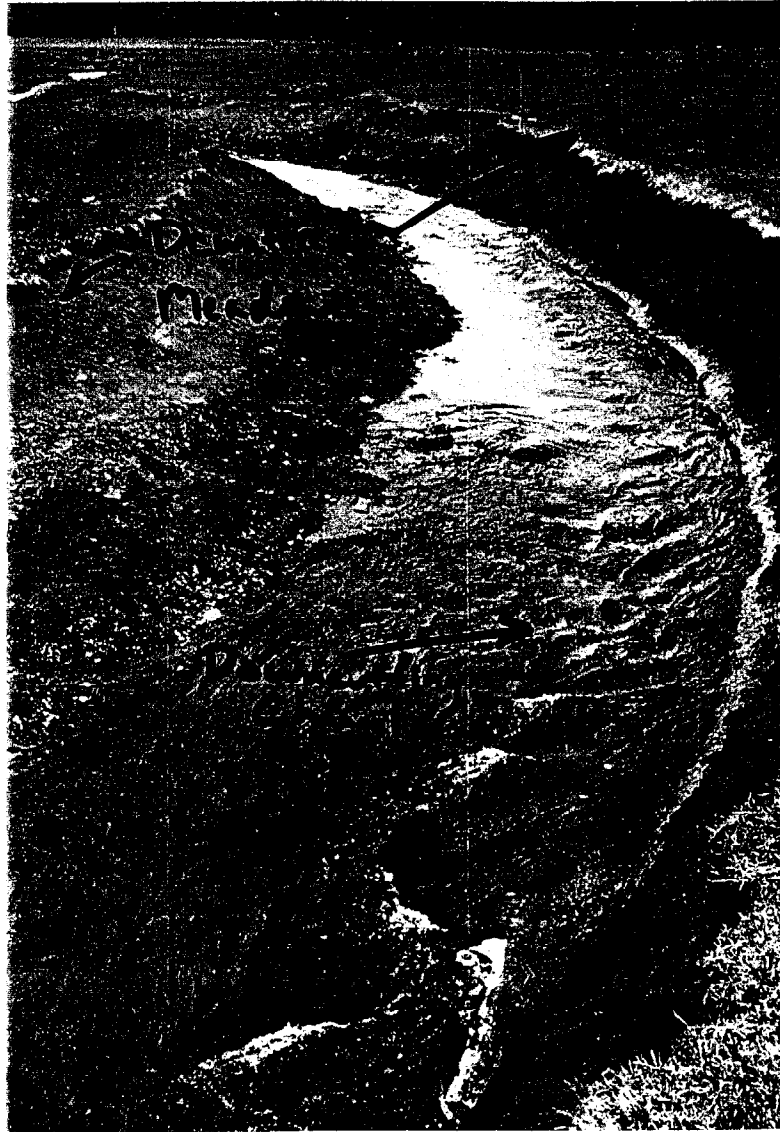
Lofer Creek below Station #1 after high spring runoff (looking upstream to the east). The orange color on the right side of the bed shows where the channel has downcut into fresh hardpan. The entrenched channel cannot recover without active restoration. For this reach, structures will need to include more large cobbles and even small boulders to build a stable platform for the gravel riffles on top (see schematic for riffle bars). The structures are need to encourage revegetation in the channel bottom and to raise the water table in the meadow.
